Re: Optical and Laser alignment services on (Machine identification)

The Right Alignment Company was asked to check the alignment of the new W&H Vistaflex press. We completed the layout work on a previous visit utilizing the Faro Laser Tracker. After the installation was completed, we were asked to check the roll alignment of the press. The alignment work was completed using Brunson optical alignment tooling. The roll alignment was verified using the FARO Laser Tracker. The monuments in the aisle (offset centerline) were used as our zero datum for checking square on the press.

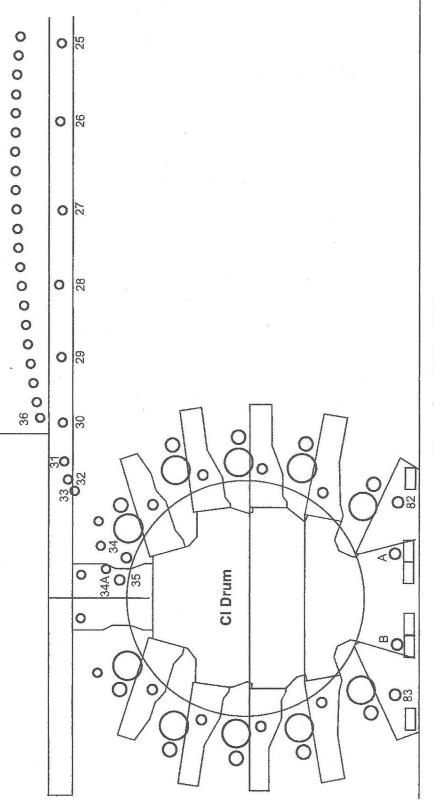
Dryer Oven

After the alignment was complete, we used the FARO Laser Tracker to recheck and verify most of the roll alignment. The readings between the two alignment processes were very similar. We tried to keep all of our alignment readings within .005". The main units were set within the .004" tolerance. There were some areas that were not checked due to not being able to get a line of site to the roll and the nip rolls were not nipped. We only checked level on the lead-in and lead-out rolls of the oven.

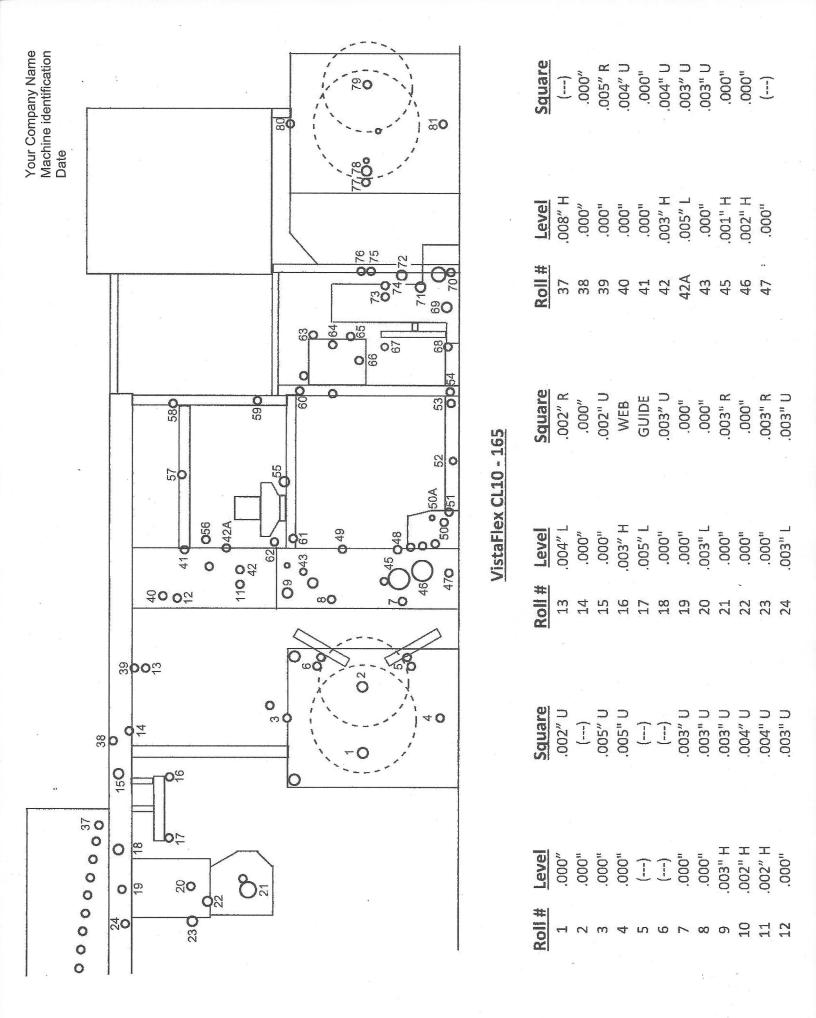
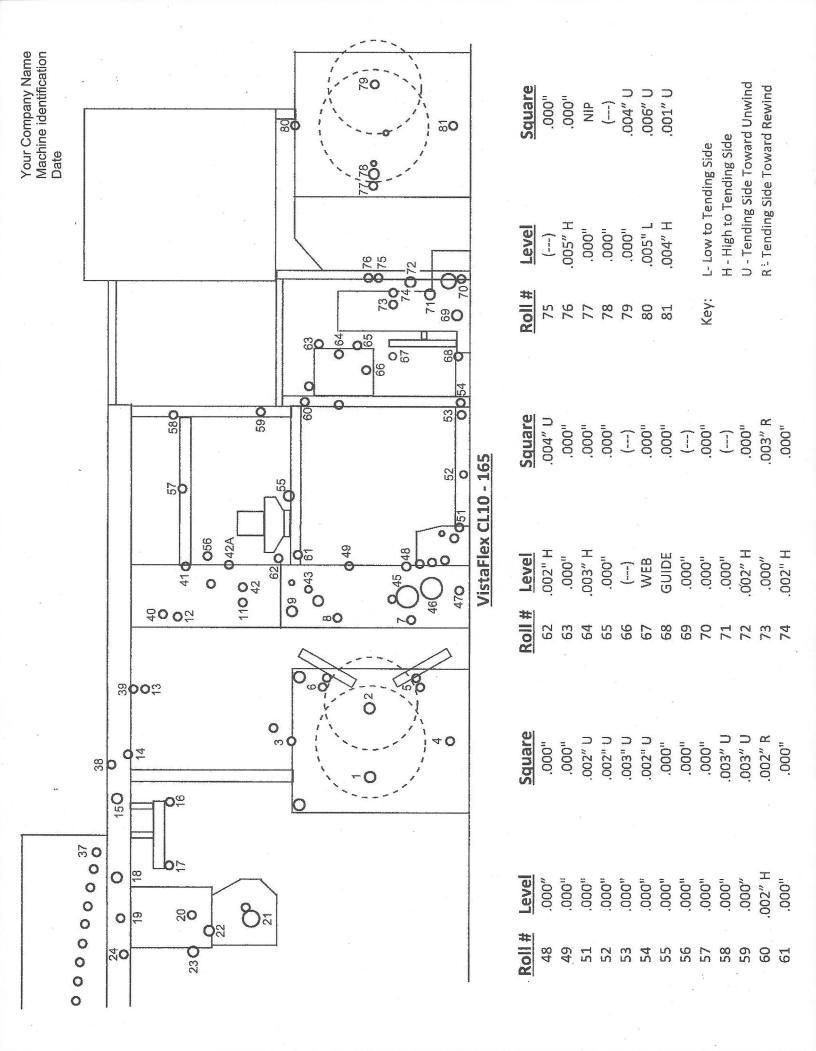
VistaFlex CL10 - 165

Square	.004" R	.003" R	(1111)	.001" U	() = 1	(()		Side	ig Side	oward Unwind
Level	,000	.003" H	.008" Н	,000	,,000°	,000.	,,000		L- Low to Tending Side	H - High to Tending Side	U - Tending Side Toward Unwind
Roll #	34A	35	36	82	83	V	83		Key:		
re	η.	8	~	Ω.	",1	~				<u>.</u>	
Squa		,007	.004	,000	000'	.005	()	()	()	000'	
Level	.002" L	H "800"	.005" L	.001" H	H "500"	H "500"	,000	.003" H	.004" H	.003" H	
Roll#	25	26	27	28	29	30	31	32	33	34

R - Tending Side Toward Rewind
